**WORKER RIGHTS CONSORTIUM ASSESSMENT  
ITIC APPAREL (DOMINICAN REPUBLIC)  
FINDINGS AND RECOMMENDATIONS**

**February 8, 2012**

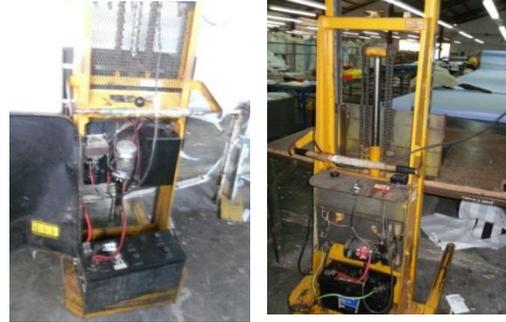
- In Building Two, the forklifts used for carrying cloth rolls have open, exposed and/or energized electrical equipment. There are oversized battery blocks on the hinged panel door of one forklift and on the other forklift the panel has been removed altogether.

- Review all electrical installations in Buildings One and Two and make repairs to the violations noted above and to any other electrical connections that do not meet Dominican legal standards.
- Develop and implement a lockout/tag-out system for the plant and train maintenance personnel on these procedures.
- Discontinue use of the elevator in Building One until such time as the manufacturer provides information about the safety of using the winch for this purpose. This information should be provided to the WRC once it has been obtained. If it is determined that the winch can safely operate the elevator, then the capacity rate for the winch-operated elevator should be visibly posted at the elevator.
