WORKER RIGHTS CONSORTIUM FACTORY ASSESSMENT

RJ Torres (Dominican Republic)
Findings, Recommendations, and Company Response

August 31, 2022

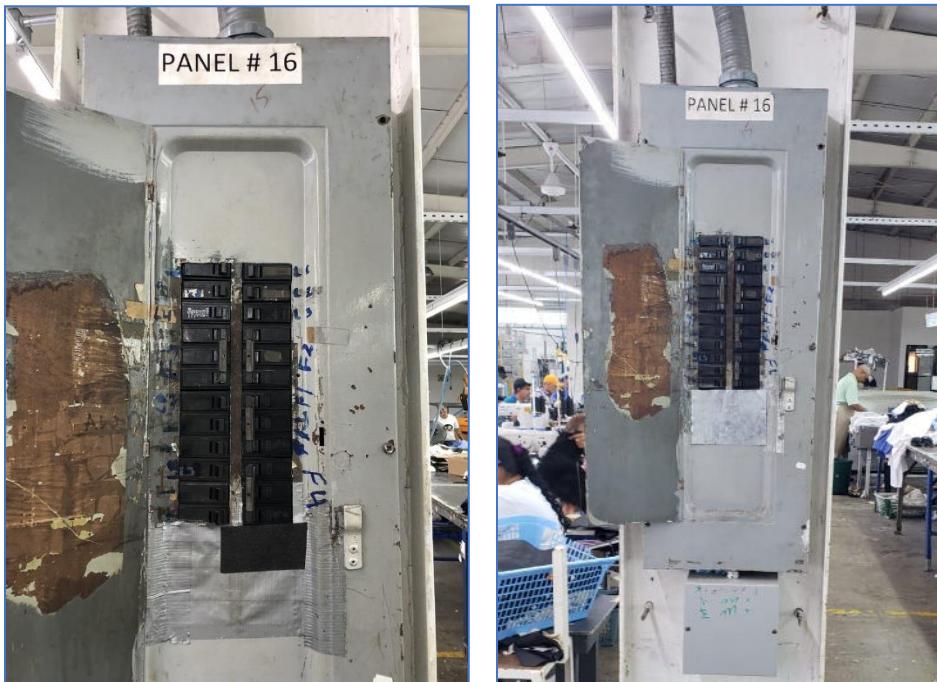
Figures 1 and 2: Combustible tape on electrical panels has been replaced with metal coverings. (Figure 2 provided by RJ Torres, August 2022)

During the factory inspection, RJ Torres replaced worn cords and disconnects in the pattern cutting room. In its response to WRC's preliminary findings issued in August 2022, RJ Torres management reported that it had repaired electrical panels by replacing tape with metal covers for open breakers. They also reported replacing temporary cords with permanent wiring with adequate protection and strong support and removing all machines needing repair from the production area. Factory management notes that it has established a procedure to change cords every 90-day period (or earlier, if damaged).

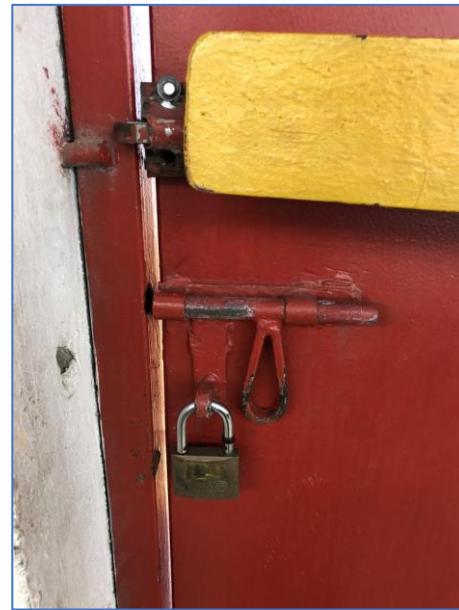
Figure 3: Emergency exit doors equipped with hasps and locks

RJ Torres responded to the WRC's recommendations in August 2022 by reporting that they are training worker teams to prevent objects protruding into the aisles in order to ensure that they remain unobstructed, and that they have repainted the aisle strips. They note that anti-skid strips on stairs have been replaced, and that management has reviewed trip hazards on steps and curbs. The factory's blacksmith contractor is removing hasps and locks from emergency exit doors.

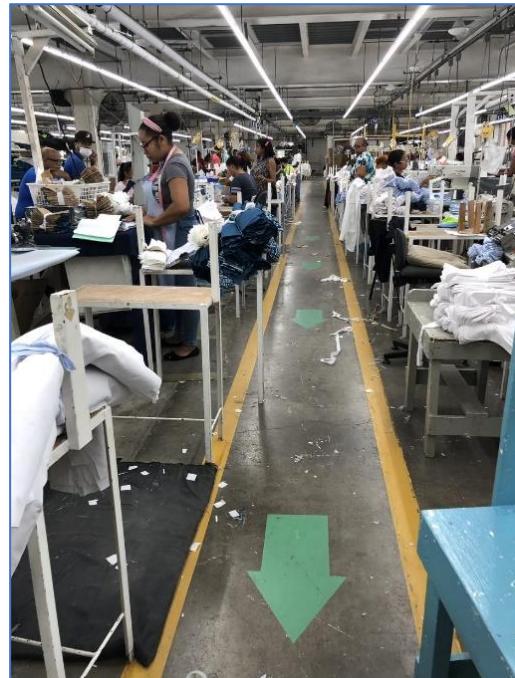
Figure 4: Partially obstructed exit path

- Relocate protruding objects to ensure all aisles remain unobstructed at all times;

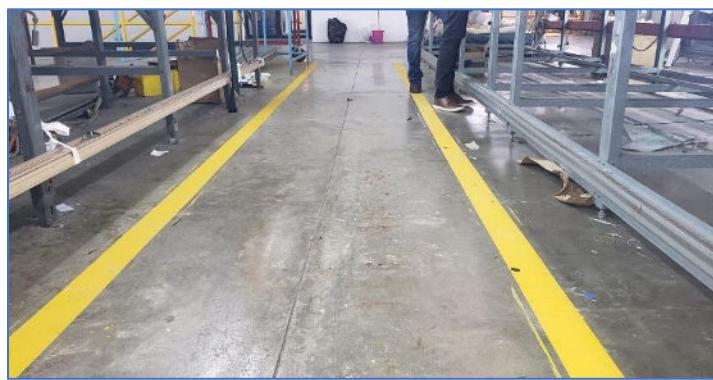
Figure 5: Repainted aisle strips. (Figure provided by RJ Torres, August 2022)

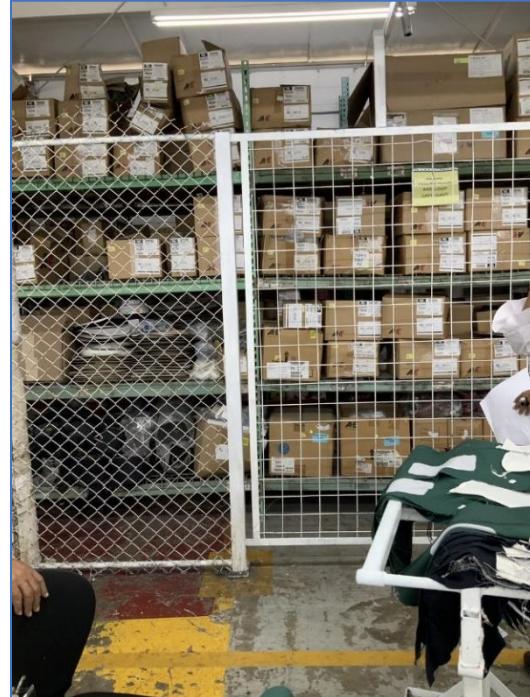
Figure 6: Combustible materials stored in the factory building

- Conduct regular vacuuming of overhead pipes and building supports to remove combustible dust buildup;
- Cover and close all open electrical junctions to prevent dust intrusion;

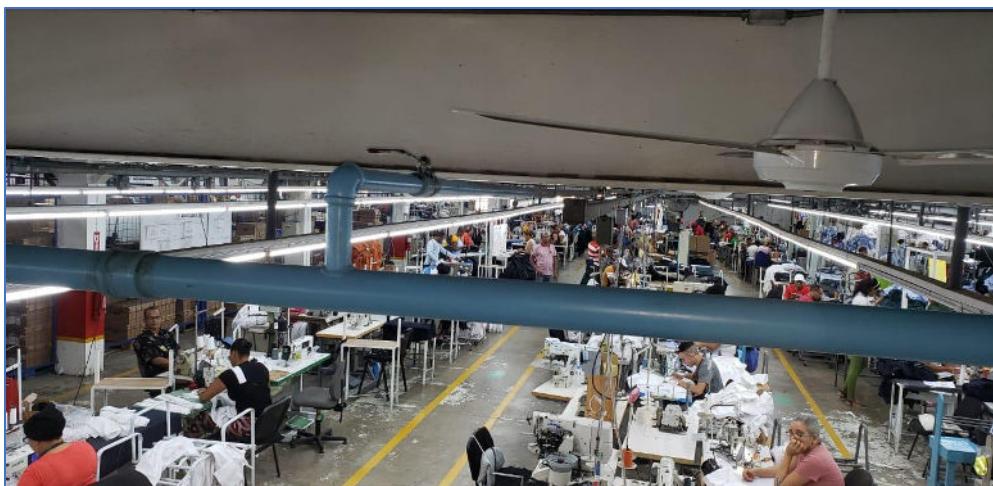
Figure 7: Dust on overhead pipes was removed. The factory has purchased four vacuum units for regular cleaning. (Figure provided by RJ Torres, August 2022)

RJ Torres responded to the WRC's recommendations in August 2022 by reporting they have removed combustible dust build-up from overhead pipes and building supports and closed electrical junctions to prevent dust intrusion. They have added four industrial vacuum units to conduct a basic cleaning daily and deep cleaning monthly, to manage lint and dust. Management reported that it had evaluated the storage area for boxes and fabric boxes to ensure these were not located near heat or electrical installations. RJ Torres management stated that it had re-inspected all fire extinguishers and retrained its management team to conduct these inspections.

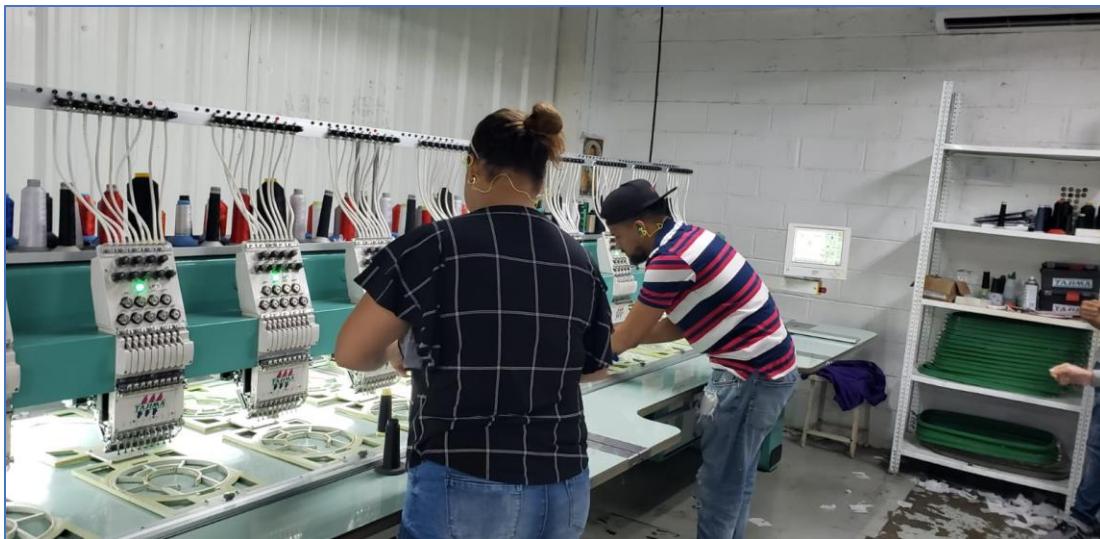
Figure 8: Workers equipped with ear plugs. (Figure provided by RJ Torres, August 2022)

RJ Torres' response to WRC's preliminary findings included a statement that they have retrained operators in the embroidery room to "understand the importance of using ear plugs at all times

during work.” They report having provided free ear plugs to operators, though they did not state whether ear plugs were made available to employees in loud areas outside of the embroidery room. The management provided documentation of their quotation request for *all* employees to undergo annual audiometric testing. Finally, they note that they have reduced the volume of music in the factory (which was not among the recommendations provided by the WRC).

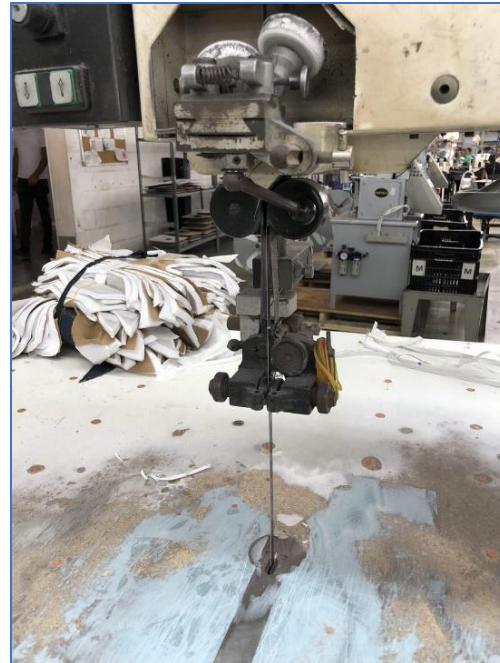
Figure 9: Fabric cutting machines missing blade guard

RJ Torres responded to WRC's initial recommendations by noting that machinery in the cutting room now has appropriate guards to cover sharp and moving parts. Management highlighted that it has replaced defective guards for sewing machines and retrained zipper punch operators to use the machine safely. Finally, management notes that it has installed a shield protector for the tool grinder.

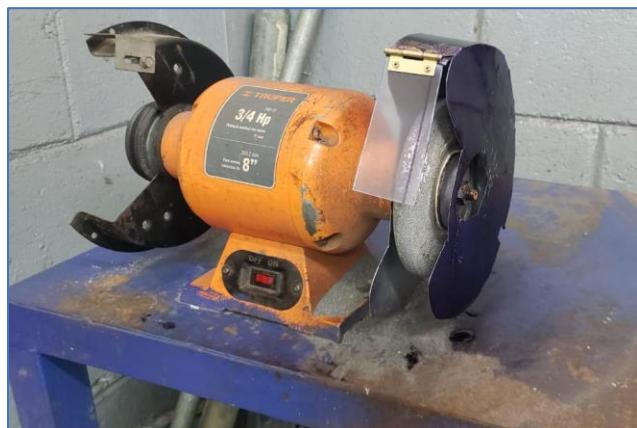
Figure 10: Tool grinder with shield protector installed.
(Figure provided by RJ Torres, August 2022)

The WRC reiterates the recommendation that, in addition to the shield protector, RJ Torres should install a tool rest for the tool grinder. The gap between the grinding wheel and the tool rest should be no wider than 1/8 inches to prevent the item being sharpened from getting caught in the gap and possibly causing injury or shattering the wheel.

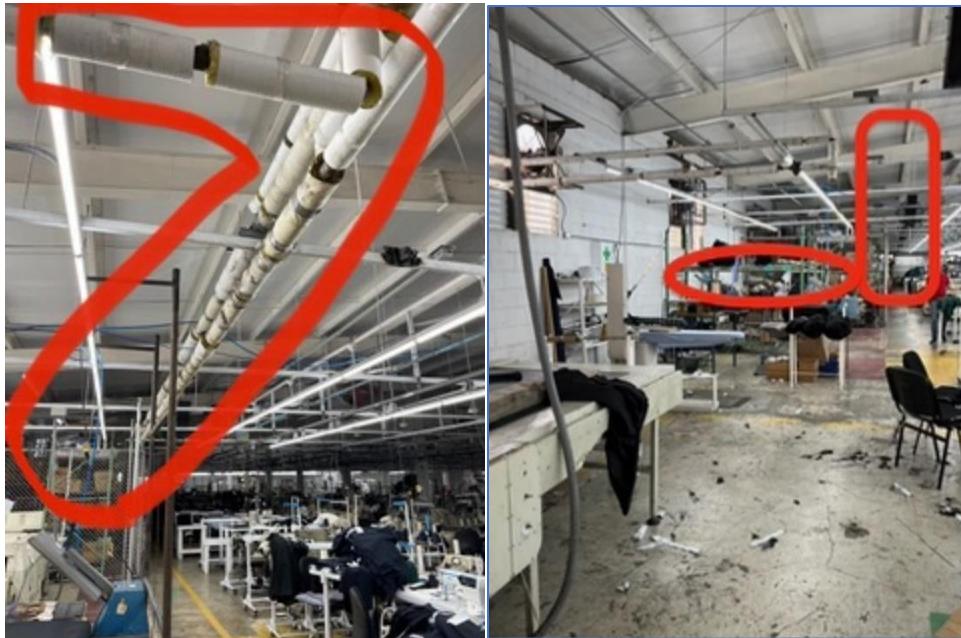
Figures 11 and 12: RJ Torres has removed a steampipe previously part of the second floor array, as one of several heat reduction measures (*Figure provided by RJ Torres, August 2022*).

These responses suggest that RJ Torres is making good faith efforts to address excessive temperatures in the facility. The WRC advises that RJ Torres continue to measure temperature levels in the factory to evaluate the effectiveness of the measures it has taken and to assess when further

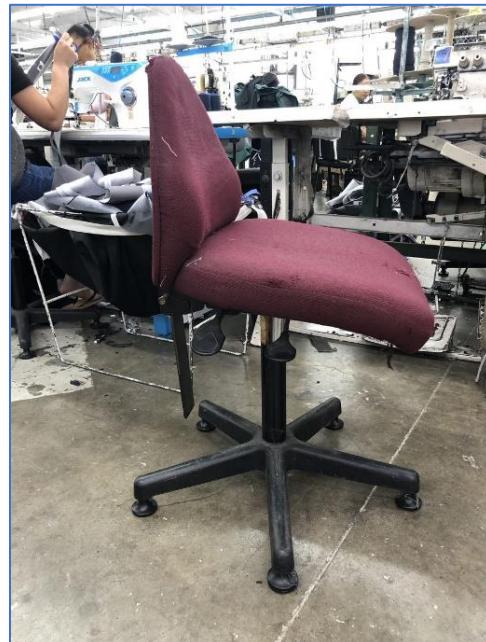
Figure 13: Chairs are in poor condition and are not ergonomically appropriate

- Replace all worn and damaged chairs and provide ergonomically adjustable chairs that comply with US OSHA standards for workers required to sit for most of the work shift.
- Replace anti-fatigue mats for workers whose tasks involve prolonged standing and modify the work process to reduce the risk of ergonomic injury.

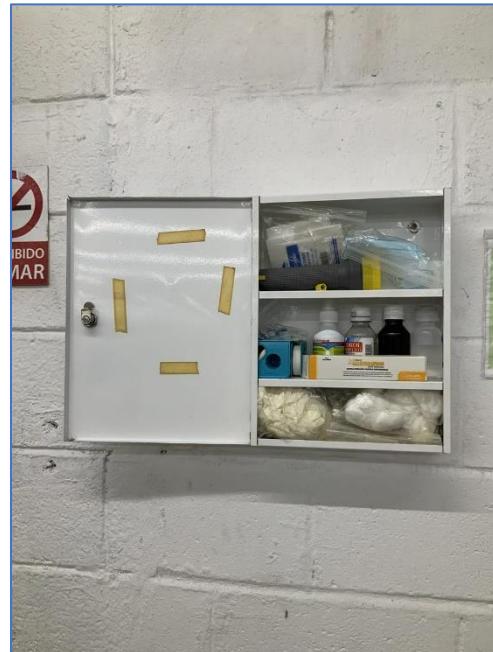
The WRC's inspection of RJ Torres found that, while there are three first aid kits on the first floor of the factory and two on the second floor, they were not appropriately stocked. The kits did not have mouth guards to use during mouth-to-mouth resuscitation. Only latex gloves were provided, which can be allergenic to some individuals. Several items from the kits' supply list were missing or were not kept in sterile packaging. The acetaminophen bottle in one kit was expired. However, the factory's first aid inspection

Figure 14: First aid station

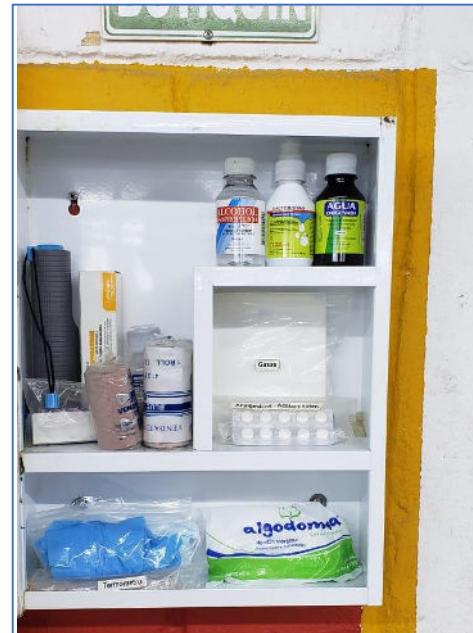
Figure 15: First aid station, with replenished supplies and labels.
(Figure provided by RJ Torres, August 2022)

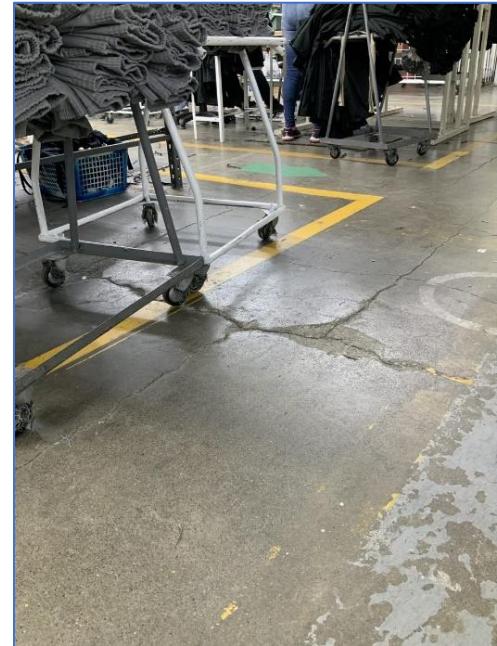
Figure 15: Cracked floor surfaces

RJ Torres stated that managers have requested floor repairs from the factory's lessor.
